## IMPORTANT PRODUCT SAFETY NOTICE

This is an important Product Safety Notice to all owners, distributors and service providers of the ProTeam GoFit 3 (model 1076620), GoFit 6 (model 1076630), GoFit 6 PLUS (model 1076650), and GoFit 10 (model 1076640) commercial backpack vacuum cleaners.

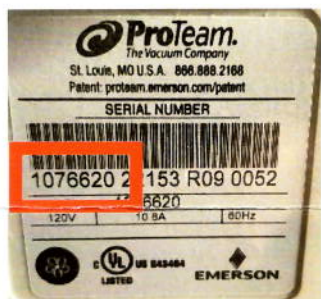
**Figure 1 – Serial Tag**  
*Serial Tag  
Model Number Identification*

2. **Inspect the Switch Box Power Cord for Signs of Wear** –Determine if you have a GoFit 3, GoFit 6, GoFit 6 PLUS or GoFit 10 model by reviewing the serial tag on the back of the product (See Figure 1). If the first seven (7) digits identifying the vacuum model are 1076620, 1076630, 1076640, 1076650 your model is involved with this Notice. Next, look for any signs of gray discoloration on the cord jacket or for exposed internal conductors (See Figure 2). Also, look for signs of intermittent motor operation during use, which may be a signal of conductor wear requiring you to Take Action.

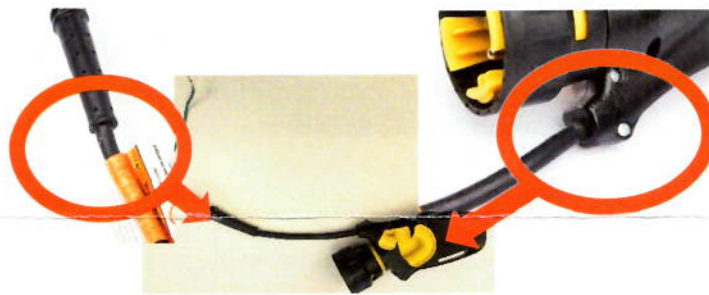
**Figure 2**  
*Locations of wear, such as gray discoloration  
or exposed internal conductors*

**Issue:** ProTeam recently received reports that some users of GoFit 3, GoFit 6, GoFit 6 PLUS, and GoFit 10 commercial backpack vacuum are not properly fastening the waist belt of the body harness and/or not wearing both shoulder straps of the harness, as required, which can cause stress on the switch box power cord and, after several months of use, can cause damage to the internal conductors (Figure 2), potentially resulting in the risk of overheating the switch box power cord and possible injury.

3. **Take Action** - If you identify wear or damage to the switch box power cord (Figure 2), immediately stop using the unit and have the damaged switch box power cord replaced before using. You can find local authorized service centers on our website, <https://www.proteam.emerson.com/en-us/knowledge-support/service-centers> . If you cannot find a local center, have questions or need more help, please contact ProTeam Customer Service at [customerservice.proteam@emerson.com](mailto:customerservice.proteam@emerson.com) or at 866-888-2168 for guidance and service options to assist in addressing the issue.

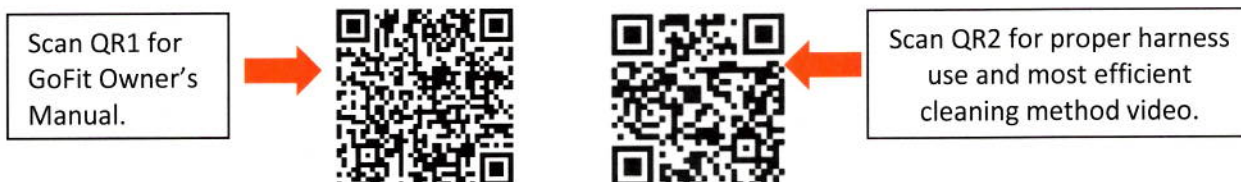
1. **Always Use Both Shoulder Straps and Fasten The Waist Belt While Operating.** Fastening the required waist belt and using both shoulder straps will assure the proper longevity of the switch box power cord and provide the best ergonomic fit for the operator. A link to the ProTeam Owner's Manual, emphasizing the importance of fastening the waist belt and both shoulder straps as well as a cord inspection tips is available at <https://www.proteam.emerson.com/en-us/knowledge-support/video>. The manual also can be directly accessed via the QR code below (See QR1). Additionally, note that wearing the full harness and sweeping the cleaning nozzle as described is proven to allow faster and more effective cleaning while reducing the ergonomic effort of the operator. The ProTeam Video Library online instruction entitled "How to properly wear your GoFit Vacuum" is available on the same website or via QR (See QR2).
