Regency 18" x 18" 14-Gauge Stainless Steel Floor Sink with Removable Grate

#600FSG1818SS

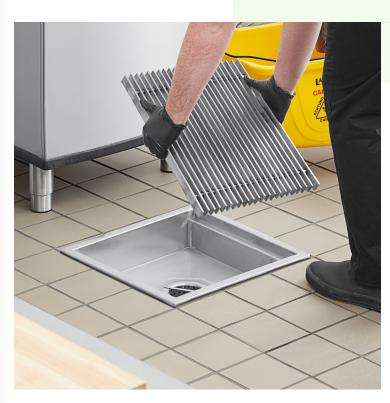
- Features a sturdy 14-gauge, type 304 stainless steel construction
- Comes with a 3" long, 4" diameter drain outlet
- Includes a removable grate and strainer basket for optimal convenience
- Strainer basket helps to prevent your sink from clogging
- Flanges mount directly to the subfloor for added stability

Maintain safe and sanitary floor conditions in your busy back-of-house area with this Regency 18" x 18" 14-gauge stainless steel floor sink with removable grate. Featuring a durable 14-gauge, type 304 stainless steel construction, this item was built for increased longevity and everyday use. Not only is its square sink design more compact than most floor troughs and great for installation beneath steam equipment in your restaurant's kitchen, allowing for efficient end-of-day draining, but also it can be utilized within any establishment that requires draining of excessive amounts of water. Not to mention, the flanges around the perimeter mount directly to the subfloor to provide added stability.

This Regency floor sink comes with a removable grate and strainer basket for your utmost convenience. Designed to prevent your drain from clogging, the strainer basket is ideal at capturing large food scraps and other debris before they go down your sink and create a blockage. The strainer basket is also easy to remove for quick and efficient cleaning thanks to its sturdy, built-in handle. Plus, this item was constructed with a 3" long drain outlet, which accommodates waste pipes up to 4" in diameter, ensuring that it meets all your versatile draining needs!
