Regency FTG-1860 18" x 60" 14-Gauge Stainless Steel Floor Trough with Grate

#600FT1860SS

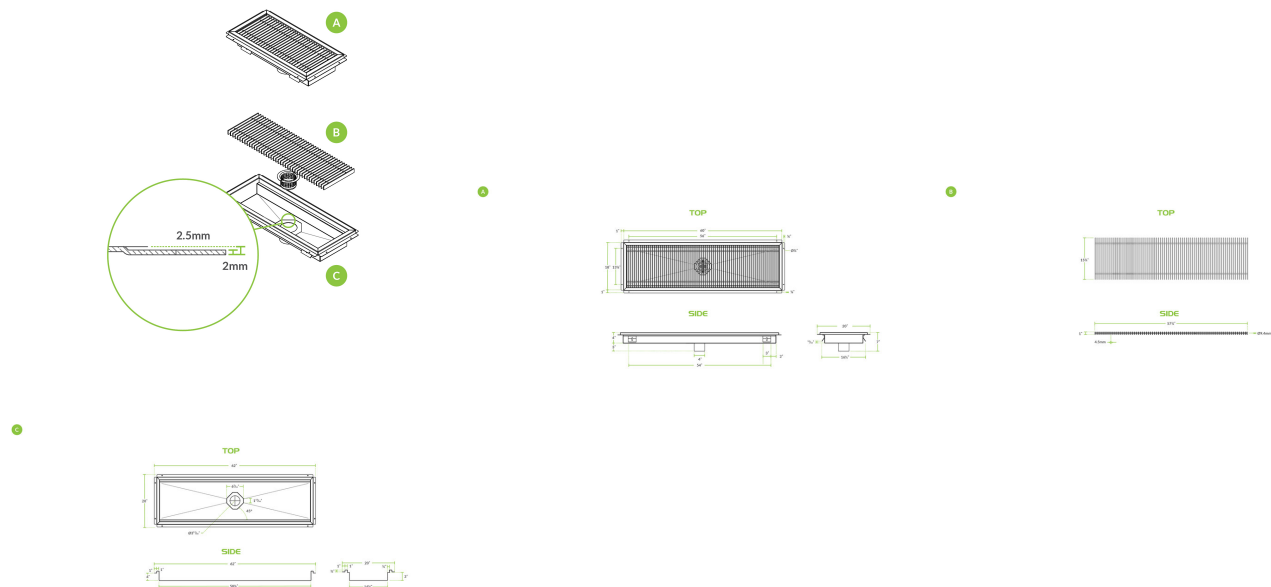
Plan View

This Regency floor trough comes with a removable 3/16" x 1" subway-style grating that boasts an even 9/16" spacing between each bar. This spacing permits fluids to easily flow through, and it blocks potential clogs while enabling equipment and casters to roll over the trough without getting stuck. Plus, this item was constructed with a convenient creased design to ensure proper draining into its 3" long plumbing sleeve, which accommodates waste pipes up to 4" in diameter. It even includes a removable strainer basket for effortless cleaning!
