Regency WT-122438-S 24" x 12" 18-Gauge 304 Stainless Steel Equipment Filler Table with Backsplash and Galvanized Undershelf

#600TB2412G

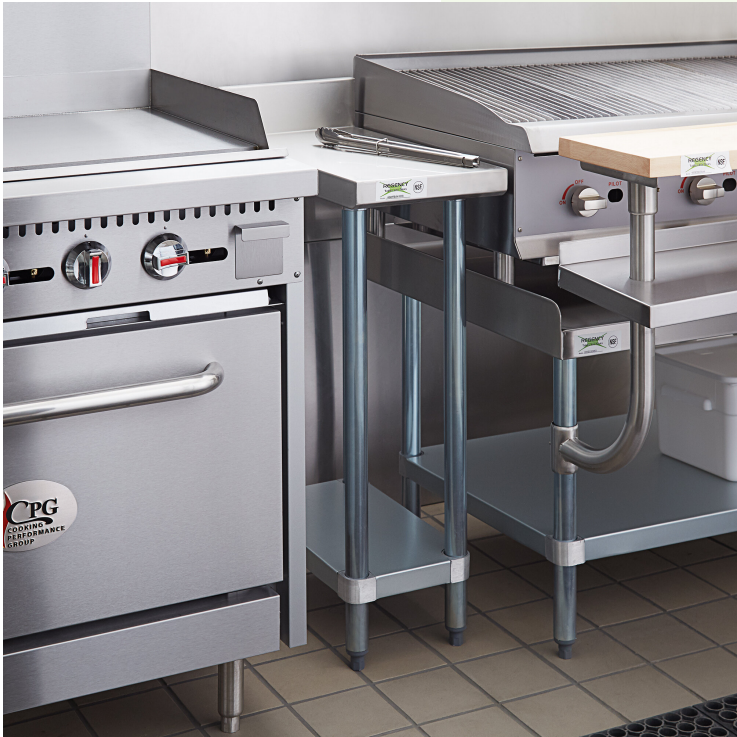
- 18-gauge type 304 stainless steel top shelf
- Galvanized steel undershelf and legs with adjustable plastic bullet feet
- Designed to fit in between two pieces of equipment
- 4" backsplash helps prevent spills
- Aluminum corner brackets on undershelf

The work table's adjustable undershelf is constructed from 18-gauge galvanized steel and is further supported with aluminum corner brackets. A 4" high backsplash is included to help protect walls and contain items on the work top. The legs of this work table are 1 5/8" in diameter and are also made of galvanized steel, with plastic feet that are adjustable up to 1".
